Static and dynamic testing of a damaged post tensioned concrete beam

Abstract. In this paper are reported the results of an experimental campaign carried out on a post tensioned concrete beam with the aim of investigating the possibility to detect early warning signs of deterioration basing on static and/or dynamic tests. The beam was tested in several configurations aimed to reproduce several different phases of the ‘life’ of the beam: the original undamaged state, increasing loss of tension in the post tensioning cables, a strengthening intervention carried out by means of a second tension cable, formation of further cracks on the strengthened beam. Responses of the beam were measured by an extensive set of instruments consisting of accelerometers, inclinometers, displacement transducers, strain gauges and optical fibres. The paper discusses the tests program and the dynamic characterization of the beam in the different damage scenarios. The modal properties of the beam in the different phases were recovered basing on the responses recorded on the beam during sine-sweep and impact hammer tests. The variation of the first modal frequency was studied to investigate the sensitivity

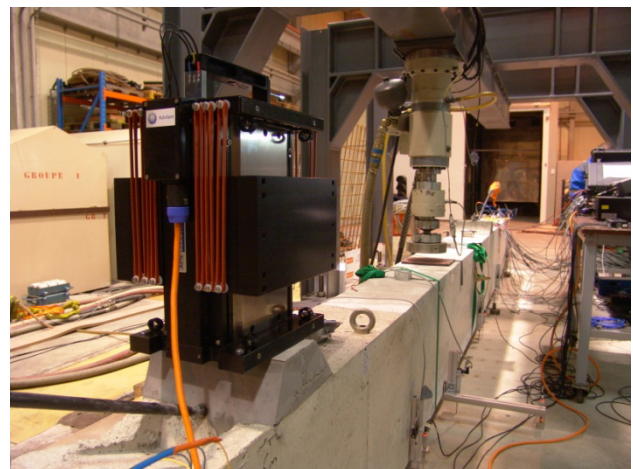
Figure 3: The specimen on the test bench with the shaker and the hydraulic jack.

Both three point bending static tests and sine sweep and hammer dynamic tests were carried out on the beam. The loads for the static tests were generated by an hydraulic jack of 100kN capacity and transferred to the beam via a steel plate (see Figure 3). The hammer tests were performed using a hammer Kiang Swiss 906B with a mass of 9kg mass to impact the beam. Sine sweep tests were carried out using a shaker APS 400 Electro-seis shaker.
